## **Observations made by ISGF Experts during the Visit to the Electric Bus Charging Depot in Bhekerai Nagar, Pune on 03/Oct/2019**

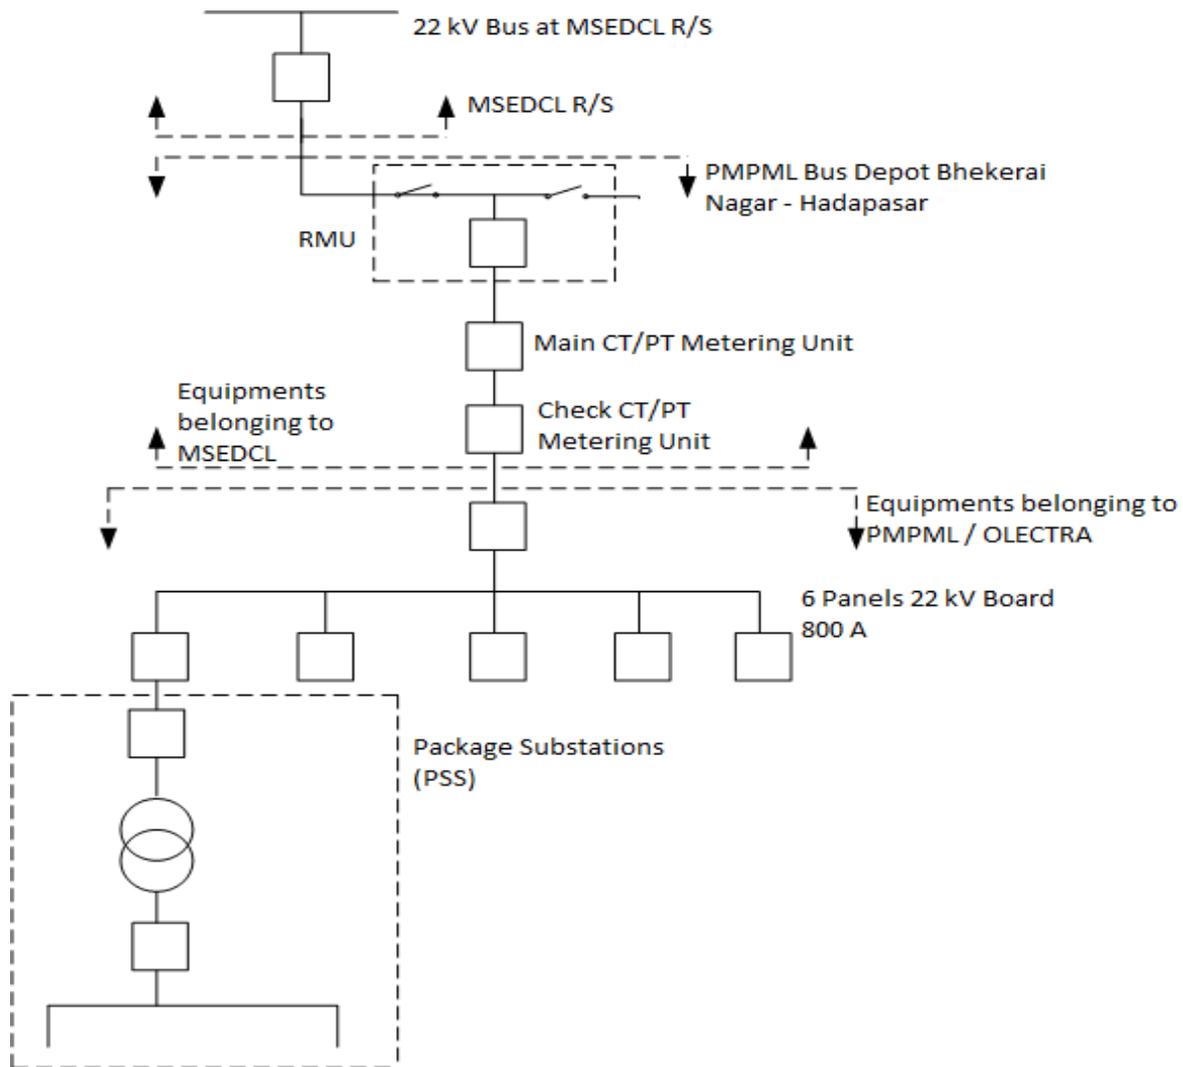
Single Line Diagram (SLD) based on the discussions held at site<sup>1</sup> with representatives of MSEDCL, PMPML, OLECTRA and Trinity Cleantech is given below (next page).

- The 22kV connection from MSEDCL is terminated on a 22kV Board with 6 panels (800 Amps).
- As of now 3 PSS of 1250kVA are commissioned.
- Each PSS have 12nos outgoing feeders (at 433 Volts) for 80 kW Chargers (100 Amps) and 2 number of outgoing feeders (at 433 Volts) for 150 kW chargers.
- These 3 PSS are now supplying electricity to 39 chargers of 80 kW and 01 number of 150 kW charger.
